# Application of Geobrugg Rockfall Barrier – the Malaysian Experience

## APPLICATION OF GEOBRUGG ROCK FALL FENCE – the Malaysian Experience

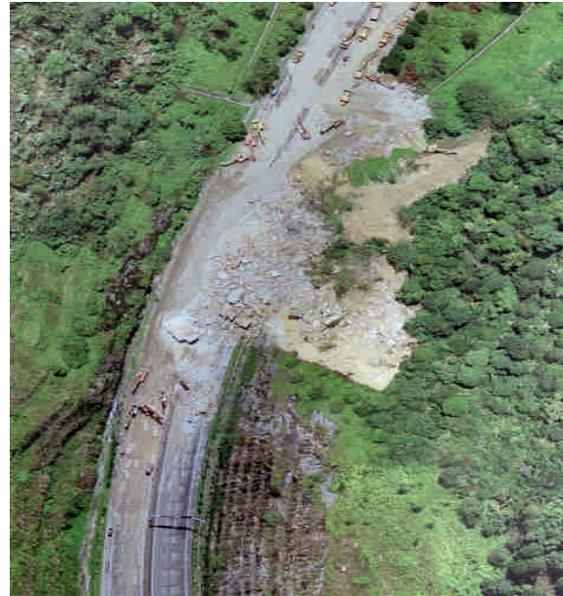
The failure occurred immediately after a period of heavy rainfall. The substantial large volume of rock debris (approx. 35,000m<sup>3</sup>) that came to rest on the expressway had blocked the expressway completely and forced the entire stretch of the expressway to be closed for 6 months for rehabilitation works (see Photo 1)

Immediately after the failure, the Engineer had commissioned site investigations that include topography survey, geological mapping, deep boreholes and laboratory tests to assess the likely cause of failure and also to provide geotechnical information required to design for rehabilitation of the failed slope. From the site investigation results, it was inferred that the rock slope failure was a complex wedge type failure. The wedge was formed by two discontinuities that daylighted out of the slope and the third discontinuity acted as release

plane. It was also demonstrated that for failure to occur there was a requirement for water pressure to be acting on the potentially unstable wedge.

*Photo 1: Aerial View of Rock Slope Failure at Bukit Lanjan Interchange*

A series of rehabilitation options were considered by the Engineer, taking the results of the site investigation results and cause of failure into account. The options include slope re-profiling, reinforcement of the rock slope, construction of tunnel (“place and cover”) and expressway re-alignment. Slope re-profiling was adopted to take account of the site conditions i.e. slope and failure geometry, soil materials above the failure, changed rock condition adjacent to the failure, and the unfavorable orientation of natural discontinuities with respect to the failure within the rock mass, etc.

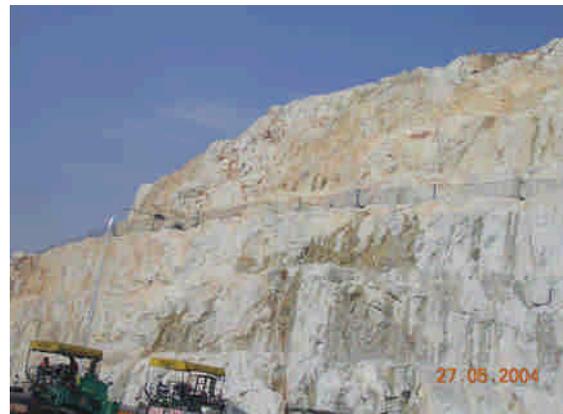
The rock fall fencing was designed to be installed at the 20m wide berm. It was aimed to contain any unwanted loose rocks above the 20 wide berm from encroaching to the expressway. The analysis showed that falling rock from the benches below 20m wide berm should be contained in the designed rock trap ditch (see Photo 2).

*Photo 2 : Completed Geobrugg Rock Fall Fence at 20m Wide Berm*

At the base of the rock cut, a 14 meter buffer zone was proposed to contain the run-out from inadvertent rockfalls. A rock trap ditch measuring 7 meter wide and 1.5 meter deep will be constructed at the toe of the slope. Rock fall fencing type AXI-150 manufactured by GEOBRUGG with impact energy resistance of 1500 kJ was incorporated as a mitigation measure to prevent small loose rock (less than 1m<sup>3</sup>) from landing on the expressway.

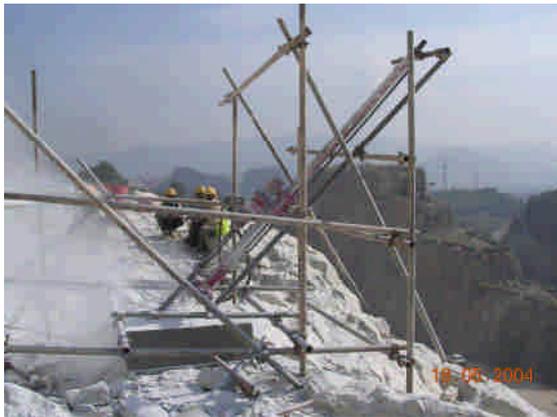
Photo 3 : Installation of Rock Anchor

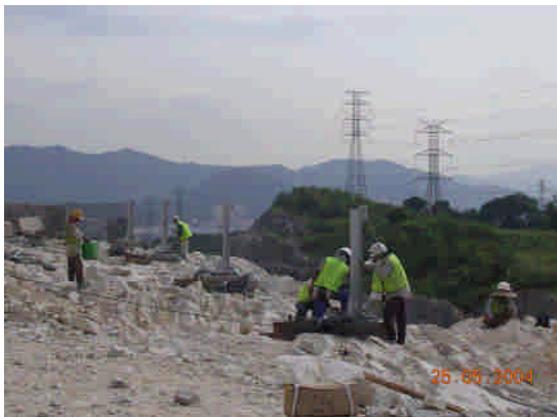
Photo 4 : Installation of Steel Post of Fence

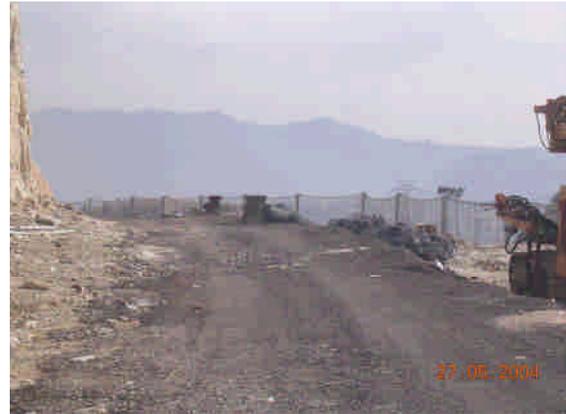
Photo 5 : Almost Completed Geobrugg Rock Fall Fence at 20m Wide Berm
